Release Notes for Cisco IOS Release 12.2(12)DA6 for Cisco DSLAMs with NI-2 Cards

These notes are Part Number OL-3177-01 Rev. C0, updated June 16, 2004

These release notes describe features and caveats in Cisco IOS Release 12.2(12)DA6 for the Cisco 6015, Cisco 6160, and Cisco 6260 digital subscriber line access multiplexers (DSLAMs).

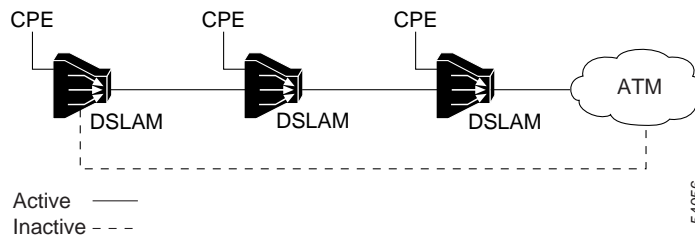
Figure 1 SPVCs Prior to Failure

Ring topology is achieved when a node in the subtend tree is attached to the ATM access to provide a physically redundant loop. Thus, when the primary ATM access or one of the ATM trunks in the subtend tree fails, the soft permanent virtual circuits (SPVCs) can be dynamically rerouted through the use of Private Network-Network Interface (PNNI) (Figure 1).

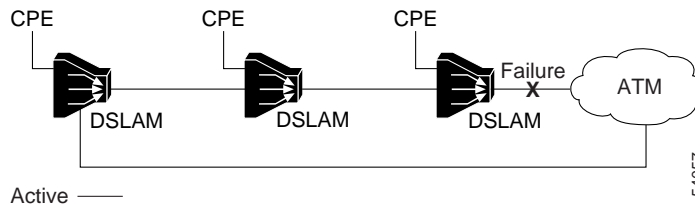
Figure 2 SPVCs Dynamically Rerouted

This redundancy requires the use of SPVCs. If you use permanent virtual circuits (PVCs) or permanent virtual paths (PVPs), redundancy cannot be provided. The use of the SPVCs allows traffic to be rerouted around the failed access point, because SPVCs leverage this feature of PNNI. When the failure occurs, the SPVCs are disconnected and dynamically reconnected across the new path (Figure 2).
