Summa Four

SDS/VCO Generic V4.2
Release Notes

61220300042-0AR

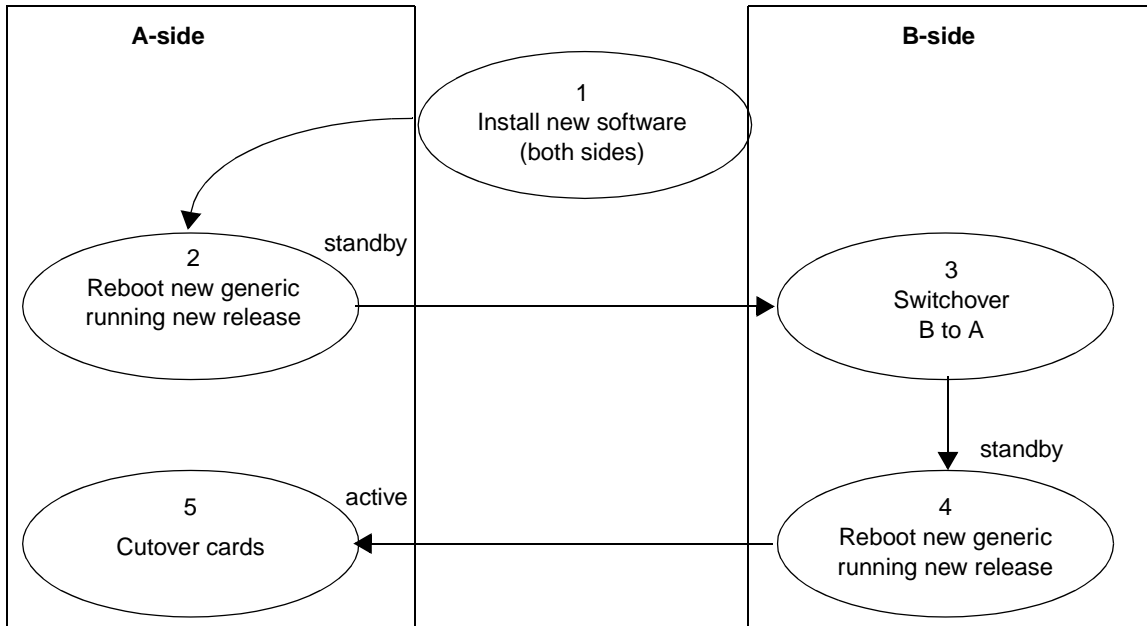
Figure 1.13: Overview of the Upgrade Process

The upgrade process is illustrated in Figure 1.13. Note in the illustration that the A-side is initially in standby mode. The A-side controller is upgraded with the new generic software and rebooted. After rebooting, a switchover is performed, making the A-side and the new software active. This procedure allows the system to maintain live traffic while being upgraded and switched to the new software.

Note: If the B-side is in standby mode, the B-side would be upgraded and rebooted first.
