**Generic Software  
Release Notes  
V5.1 FSR00 PUN21**

61220300051-03P

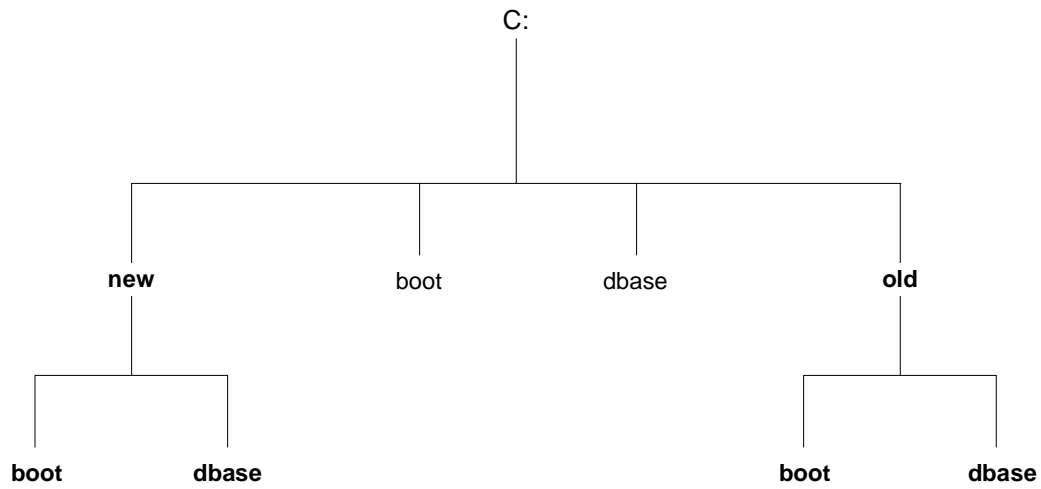
TP000114

The directory structure that is required by the upgrade process is shown in *Figure 5.2*. The directories created for the upgrade procedure are shown in bold; they are automatically created by the generic software when you select the Prepare for Install option. If they already exist, any existing files are removed from the directories. The directories themselves are maintained, and are used during the upgrade process.

Figure 5.2: Upgrade Process Directory Structure
